APPLICATION STORIES

Customer: A manufacturer of PVC cutting equipment

Machinery Involved: Automated CNC controlled PVC cutter.
Cutting blade is 60" long.

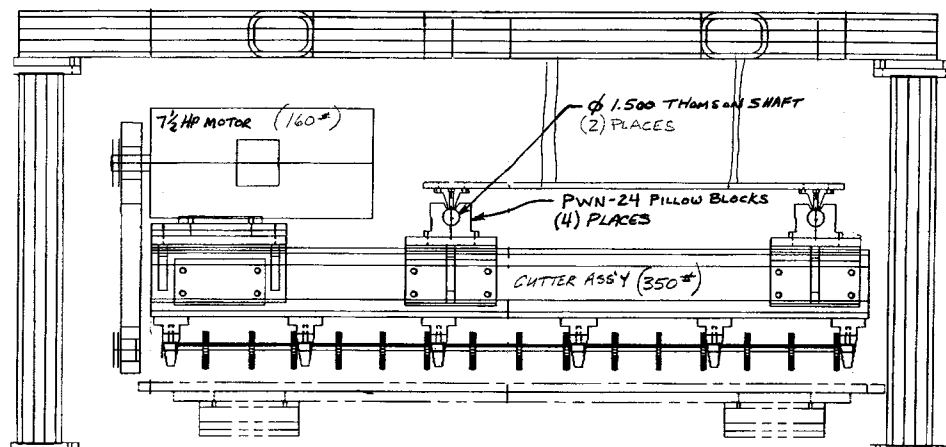
Description of Environment: Overhung load, vibration from motor.

Description of Problem: Motor vibration was causing twin pillow blocks and ball bearings and shafting to fail.

Solution: Retrofit with single Simplicity pillow blocks and bearings.

Customer Reaction to Solution: Simplicity dampened vibration and saved customer money with the switch from twin to single pillow blocks.

Simplicity Part Used: PN24

Qty of Bearings Used: 4 per machine
